Fixing Instructions for Maximair 50/75/100

Continuous Louvres Flanged Box Louvres Double Bank Louvres

McKenzie-Martin Ltd

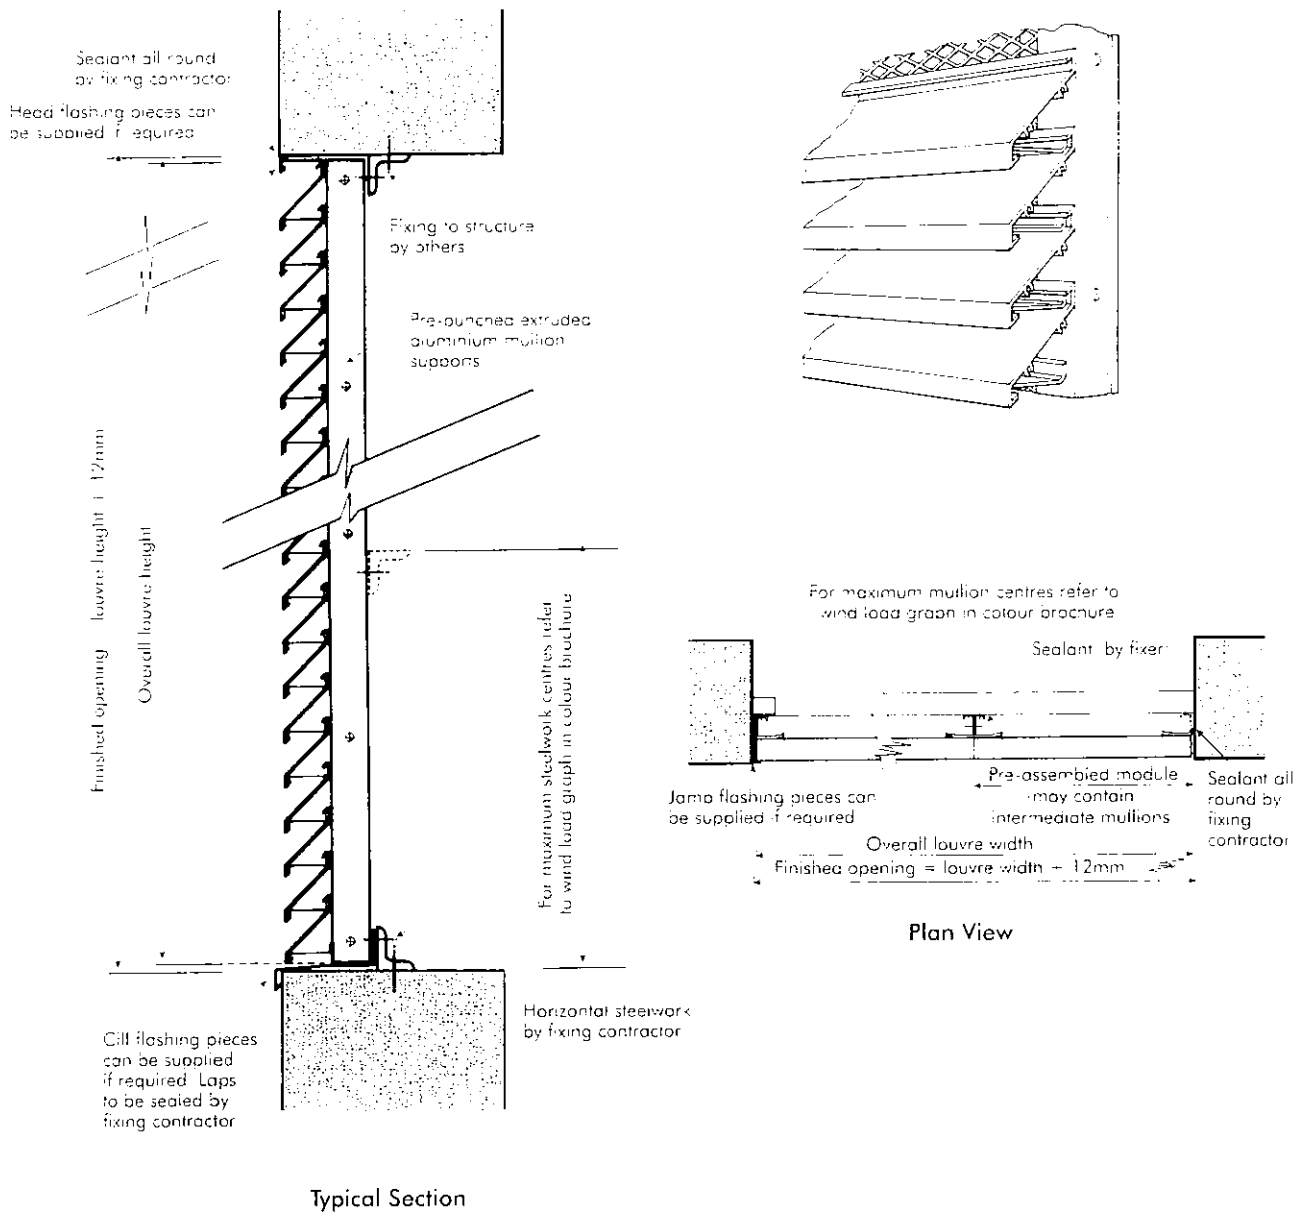
Continuous Single Blade Louvre (contd.)

Typical construction details and suggested methods of fixing into sidewall cladding and brickwork openings

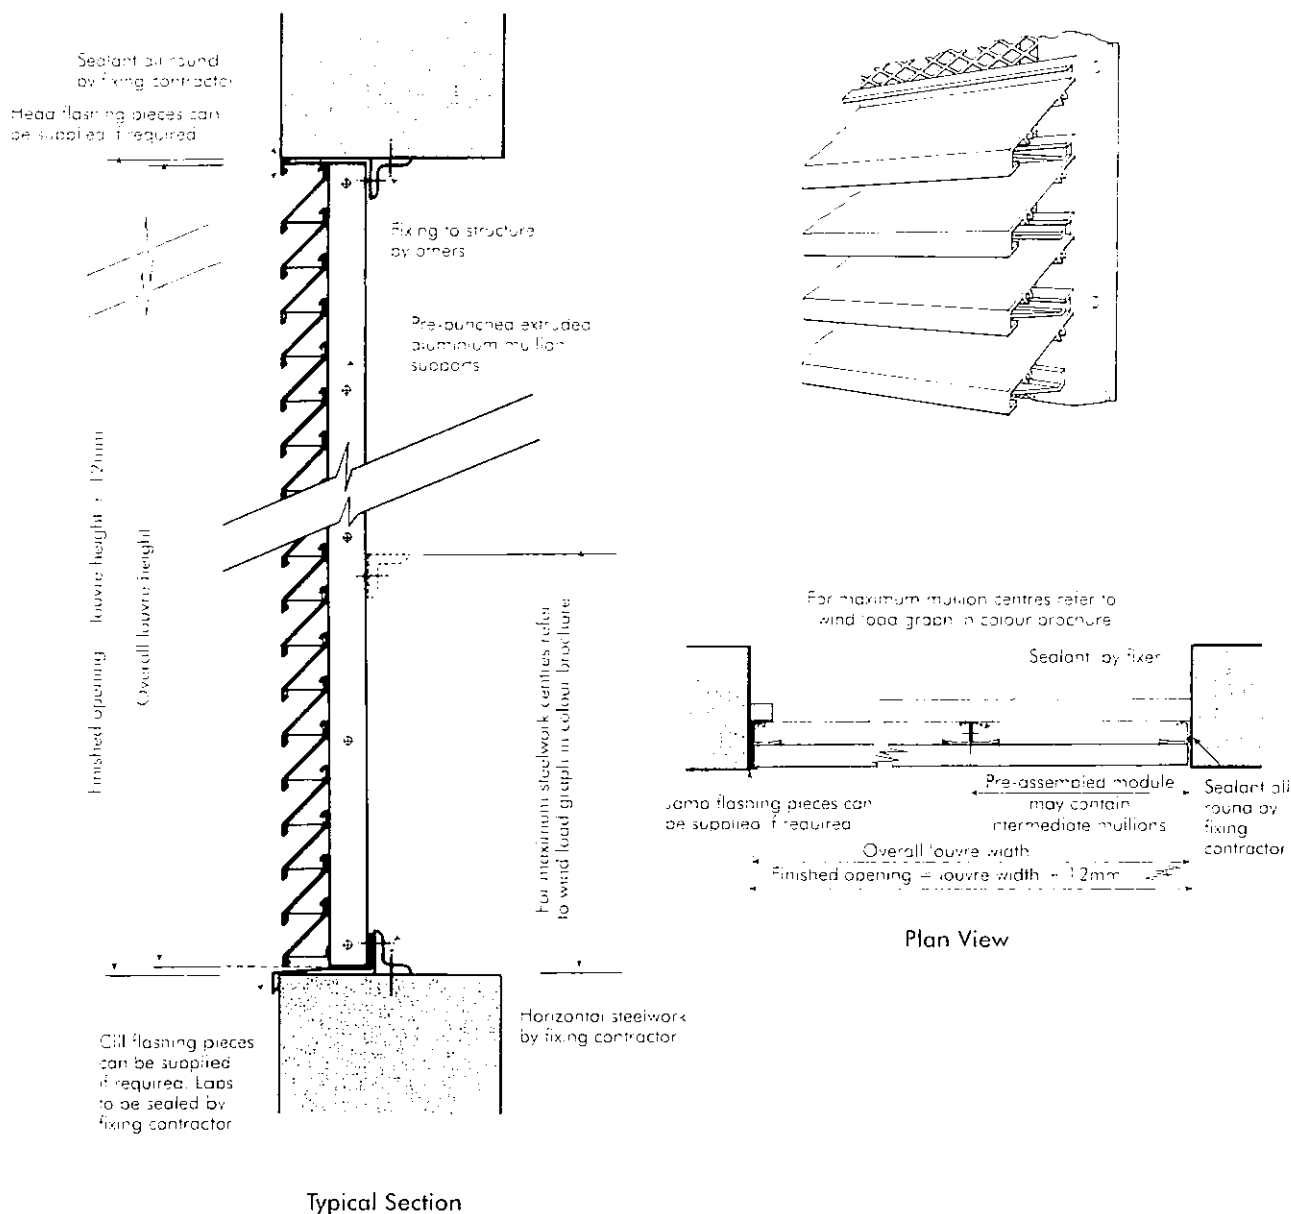
Continuous Single Blade Louvre (contd.)

Typical construction details and suggested methods of fixing into sidewall cladding and brickwork openings

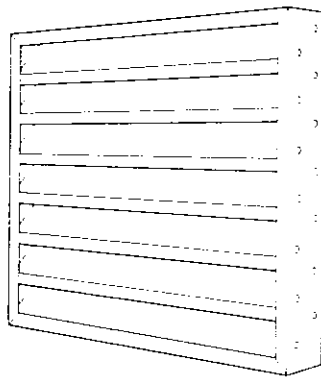
Fixed Box Single Blade Louvres

(Fabricated rims and flanges)

Louvres welded at corners

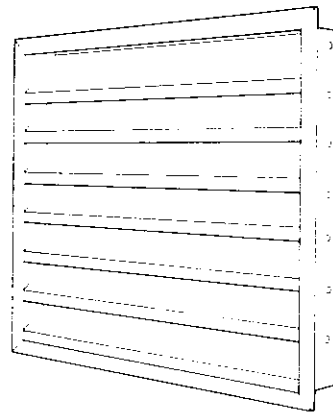
Box flanges can be positioned to suit most mounting details

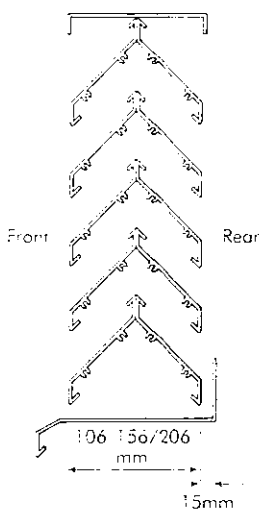
Fixed Box Louvre (Side View)

Double-Banked - Fixed Box/Continuous Louvres

Boxes welded at corners

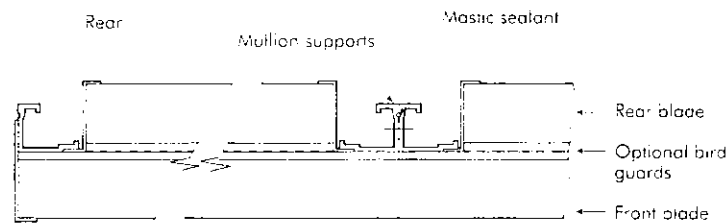
Continuous Louvre (Plan View)

On continuous double-banked louvres, bottom flashings may be supplied in 3,000mm lengths with u.c. plates. Fixer to make sure mastic seals are in place.
